Post-Endodontic Restorations Using Direct Fiber-Reinforced Composite Resins: A Case Report

Latifa Hammouda^{1,*}, Amira Kikly², Fouad Brigui², Ameni Chadlia Belghith², Wided Glii², Neila Zokkar³, Nabiha Douki³

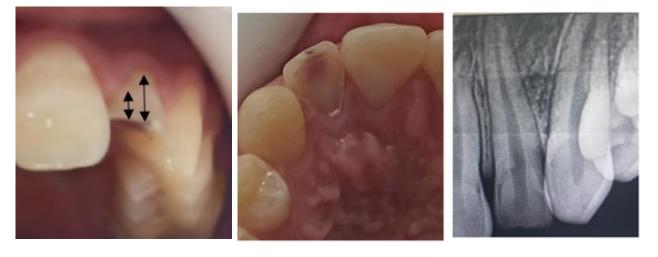
An 18-year-old male patient reported to the department of dentistry at the university hospital Sahloul with a chief complaint of sever destruction of lateral left upper incisor 22. Patient's medical history was noncontributory. Patient gave a history of trauma for 4 days (Figures 1,2). Intraoral examination revealed an amelo-dentinal fracture with the pulp visible through transparency in 22 and the loss of more than half the crown. Intraoral periapical radiographs confirmed a clinical diagnosis (Figure 3).

Figure 1: Pre-operative clinical view revealed amelo dentinal fracture with pulp exposure. Note the dentin in the cervical third guaranteeing the adequate ferrule height (black arrows)

Figure 1: Pre-operative clinical viewFigure 2: Pre operative clinical viewrevealed amelo dentinal fracturerevealed the pulp exposure.

22 were indicated for pulpectomy, followed by glass fiberreinforced composite resin post and composite buildups.

The treatment strategy was divided into 2 steps for 22: Endodontic treatment in the first consultation and construction of the restoration in the second step.

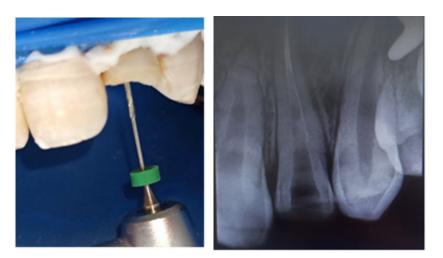
Figure 5: Retreatment of tooth 22 is performed up to WL- 5mm using Largo drill.

Figure 6: Radiographic control after 22 retreatments.

The preparation of the fiber-post space was performed 1 week after the endodontic treatment. Following the application of a rubber dam and the removal of temporary filling, the intra radicular post space is performed by drilling the canal with Largo drill n° 1 (7/10 mm in diameter) and n° 2 (9/10 mm in diameter) to remove endodontic obturation

material, leaving in the apical third 5 mm of gutta percha to ensure apical tightness (Figures 5,6). Then, the size-matched drill corresponding to the type and diameter of the chosen post was selected (Figure 7). The post was sectioned two millimeters below the occlusal surface using a diamond disc (Figure 8). A radiography with a drill in place is made to control the drilling axis and depth (Figure 9). The selected post is then decontaminated into alcohol.

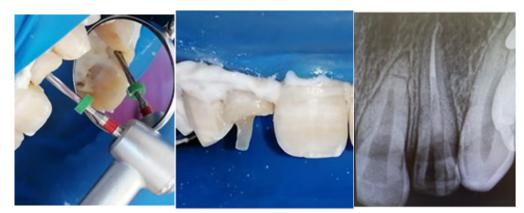
Figure 7: Post space preparation.

Figure 8: clinical post fitting ((pre-cutting of post with diamond disc) Figure 9: Post fitting (4mm intracoronal) + RX post in place

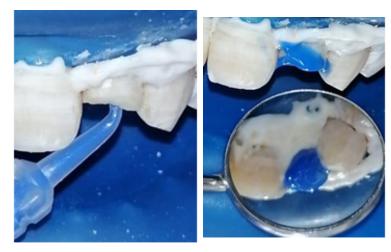
Figure 10: Intraradicular etching with 37% phosphoric acid gel.

Figure 11: Coronal etching with 37% phosphoric acid gel.

The spaces made for the post were acid etched, rinsed with water, and dried (Figure 10): An endodontic needle can be used to facilitate rinsing of the apical part of the post space. The light-cured bonding is applied with a Microbrush®

The coronal area was etched with 37% phosphoric acid gel on peripheral enamel then dentin for 30 and 15 seconds respectively (Figure 10). Then washed, and bonded using a light cure for 20 seconds. Light curing is performed in 2 steps: 3 second light curing with a soft intensity to gelate the resin and to allow easy removal of the excess, followed by a 40 second light curing.

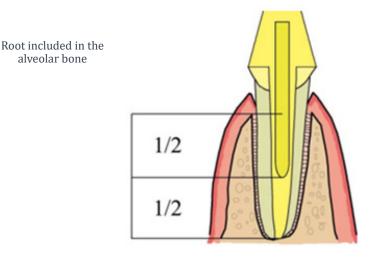
Schema 1: Length of the post according to the alveolar bone.

Preserving radicular dentin is essential, and therefore, the canal should not be significantly enlarged beyond the shape created during root-canal instrumentation [9]. In our case, the instrumentation involved the use of a final instrument with a 4% taper, combined with chemical disinfection. Regarding the insertion depth of root canal posts, guidelines generally recommend that the post length should match the clinical crown height. Additionally, the post length should occupy approximately one half to two-thirds of the root, while the post length itself should be about half of the length of the root that is supported by bone [3]. Sorensen and Martinoff found a success rate of 97% when the post length was at least equal to the crown height [11]. In this report, a fiber post with a length corresponding to 2/3 of the root was used. A 6 mm length of Gutta-percha was retained to ensure apical sealing. The fiber was chosen to float inside the canal in order not to be in contact with the dentin walls and to be surrounded by the reconstitution resin. But in a way that leaved space to inject a thin layer (from 1 to 1,3 mm) of dualresin [10].
